**U.S. Department of the Interior
Bureau of Land Management**

**Big Springs Assessment
Dickshooter Use Area
June 18, 2015**

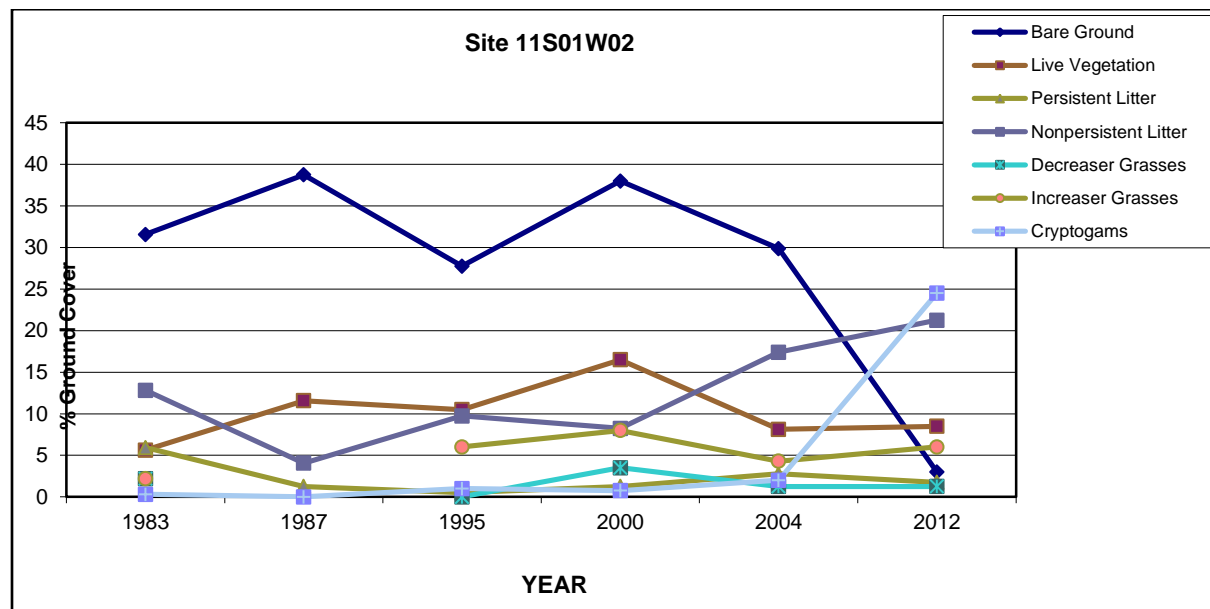
Figure 3. Rangeland trend from 1983 to 2012 at 11S01W02 in Pasture 8N.

Trend data indicated a generally **static** trend in persistent litter, live vegetation basal cover, and basal cover of increaser and decreaser grasses at 11S01W02 between 1983 and 2012 (Figure 3). Bare ground and biological soil crusts (cryptogams) showed a strongly complementary change between 2004 and 2012, possibly reflecting the influence of several normal or wet years.

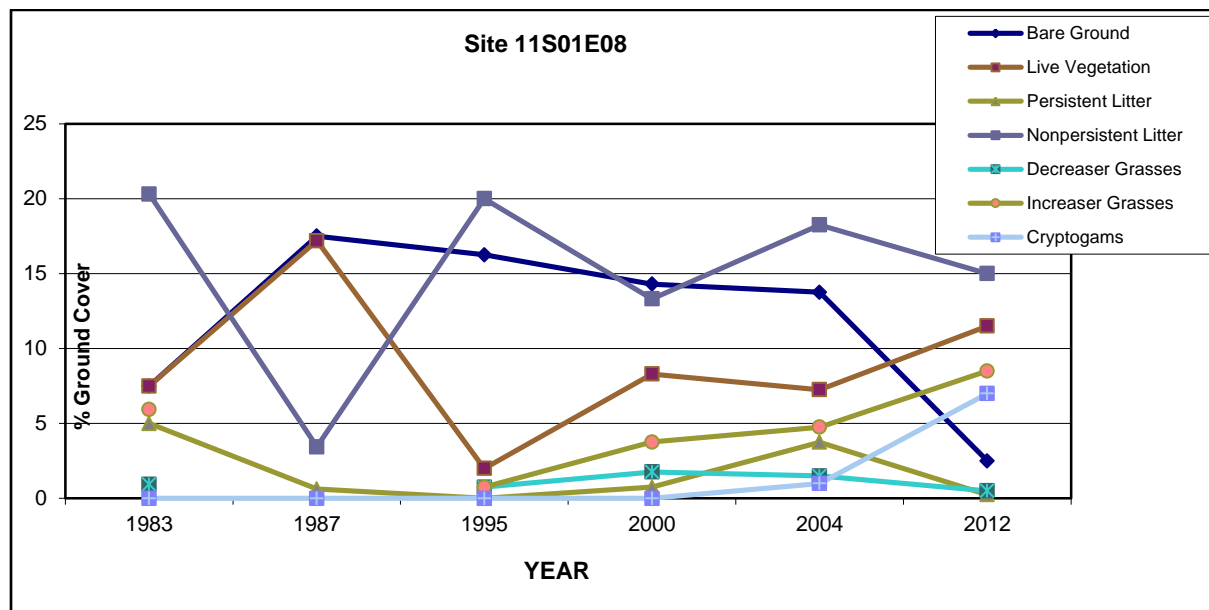
Figure 4. Rangeland trend from 1983 to 2012 at 11S01E08 in Pasture 8N.

Trend data indicated a generally **static** trend in bare ground and basal cover of decreaser grasses at 11S01E08 (Figure 4). Live vegetation, increaser grass basal cover and persistent litter all showed some fluctuation between 1983 and 2012. Live vegetation showed greater basal cover in 1987 than in the other years; and increaser grass basal cover and persistent litter had their lowest values in 1995 after a period of below-normal precipitation during 1987 to 1994. Overall, live vegetation, increaser grass basal cover and persistent litter were all static between 1983 and 2012. Biological soil crusts increased after 2000 and markedly after 2004.

There was no correlation between bare ground and non-persistent litter cover during 1983 to 2012 at trend site 11S01E08, but the two were negatively correlated at site 11S01W02. Both sites have a relatively high cover of rock and gravel, although more fine soil is evident at the surface at 11S01W02. Non-persistent litter cover declined during 1983 to 1987, but recovered to its original levels at both locations by 2012.

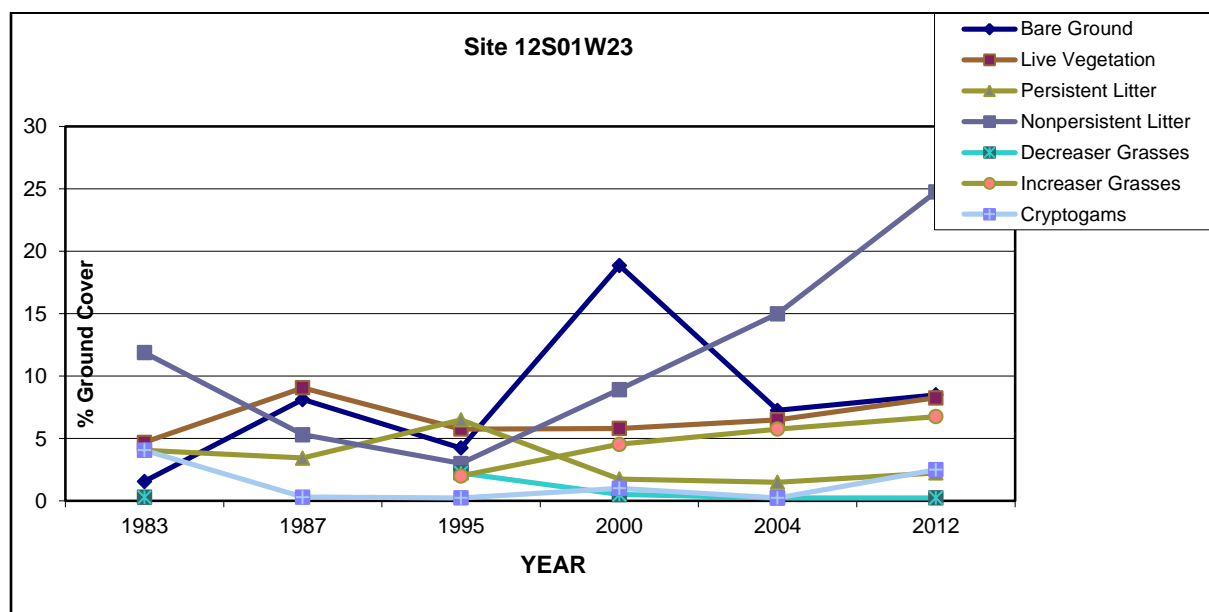
Figure 5. Rangeland trend from 1983 to 2012 at 12S01W23 in Pasture 8S

Trend data for 12S01W23 (Figure 5) indicated a generally static trend in live vegetation basal cover, in basal cover of increaser and decreaser grasses and in biological soil crusts between 1983 and 2012. This study site has inherently low bare ground that biocrusts could potentially colonize. Bare ground cover showed some fluctuation, with greater bare ground in 2000 than in the other years; but was static overall, without any clear correlation with growth year precipitation. Persistent litter also showed some fluctuation, but with a static trend overall.

There was no statistical relationship between bare ground and non-persistent litter cover at either trend site during 1983 to 2012. Both have an inherently high cover of gravel and rock, although more fine soil is evident at the surface at 12S01W32. Non-persistent litter cover declined through 1995 after a period of below-normal crop year precipitation during 1987 through 1994, but recovered to its original level at both by 2004 and continued to increase through 2012 after a period of normal or wet years that extended through 2011.

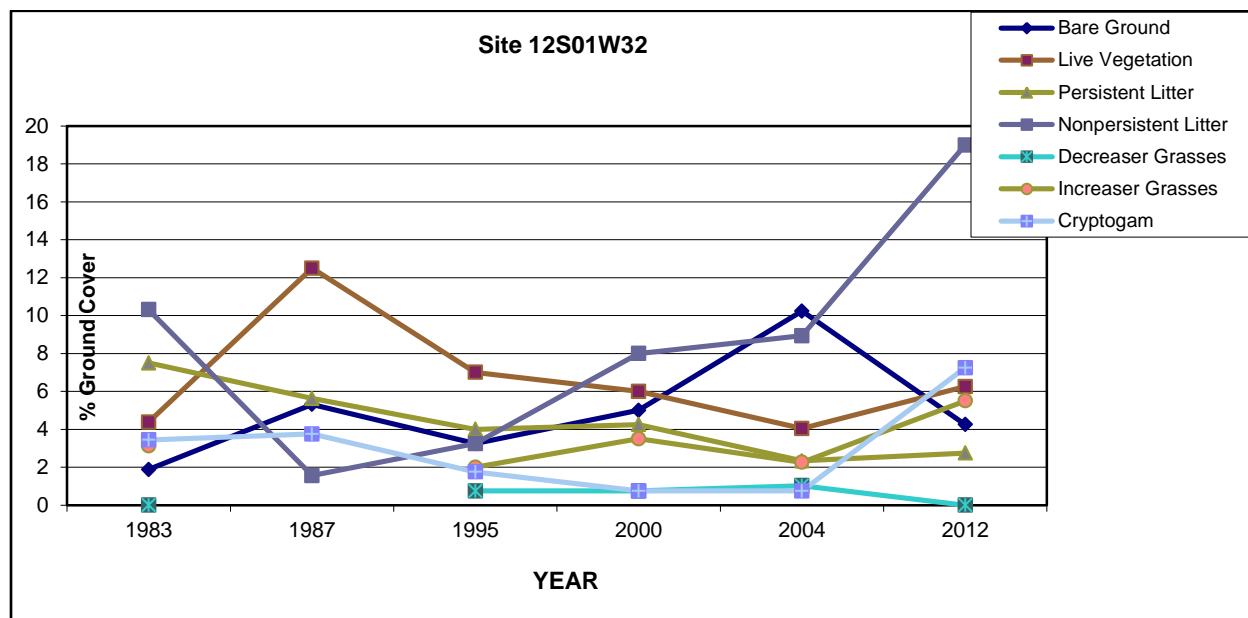
Figure 6. Rangeland trend from 1983 to 2012 at 12S01W32 in Pasture 8S

Trend data for 12S01W32 (Figure 6) indicated a static trend in persistent litter, bare ground, and basal cover of increaser and decreaser grasses between 1983 and 2012. Live vegetation basal cover showed

some fluctuation, with greater basal cover in 1987 than in the other years. However, live vegetation basal cover was also static overall. Bare ground and biological soil crusts showed a strongly complementary change between 2004 and 2012, possibly reflecting the influence of several normal or wet years.

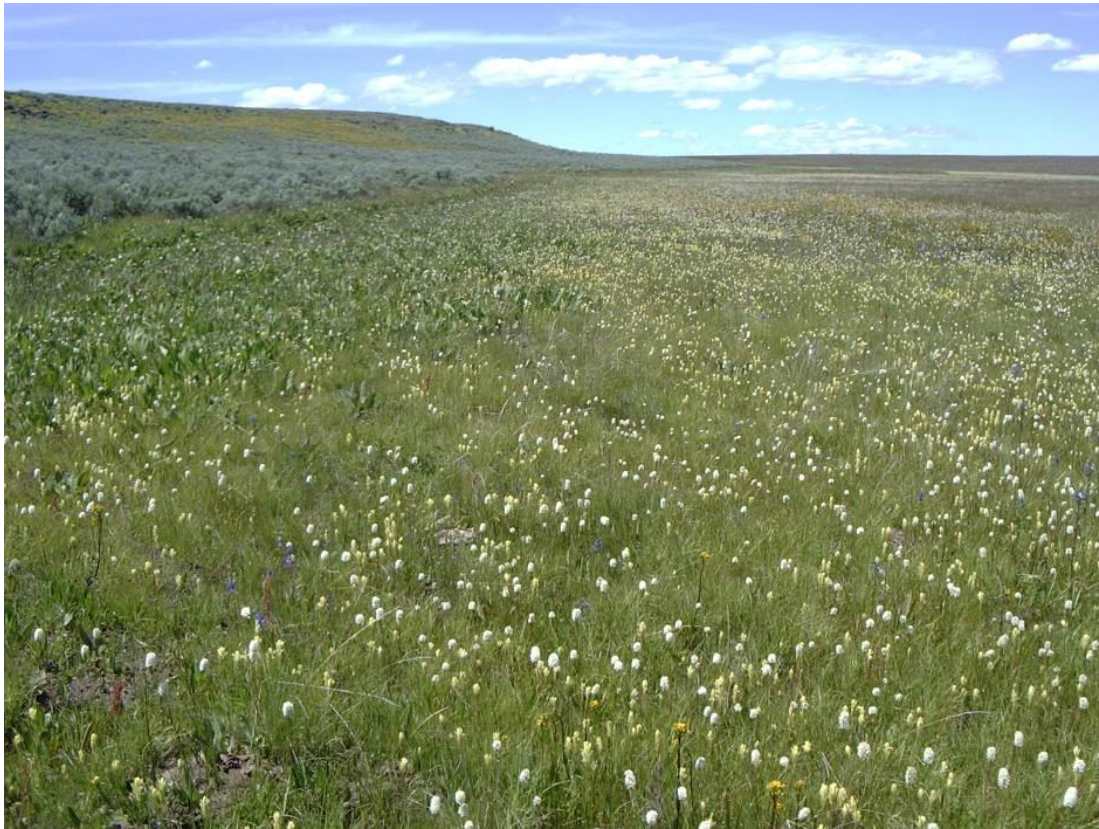
Figure 10. Wet meadow area, Pasture 8N, October 4, 2005

Pasture 8N includes forb-rich, seasonally wet meadows adjacent to strips of big sagebrush under low mesa rims. This configuration is an excellent habitat combination for sage-grouse. These meadows and big sagebrush stringers are generally in good condition, with varied forbs and vigorous grasses (See Figure 10). Meadows in this pasture are used extensively by sage-grouse.

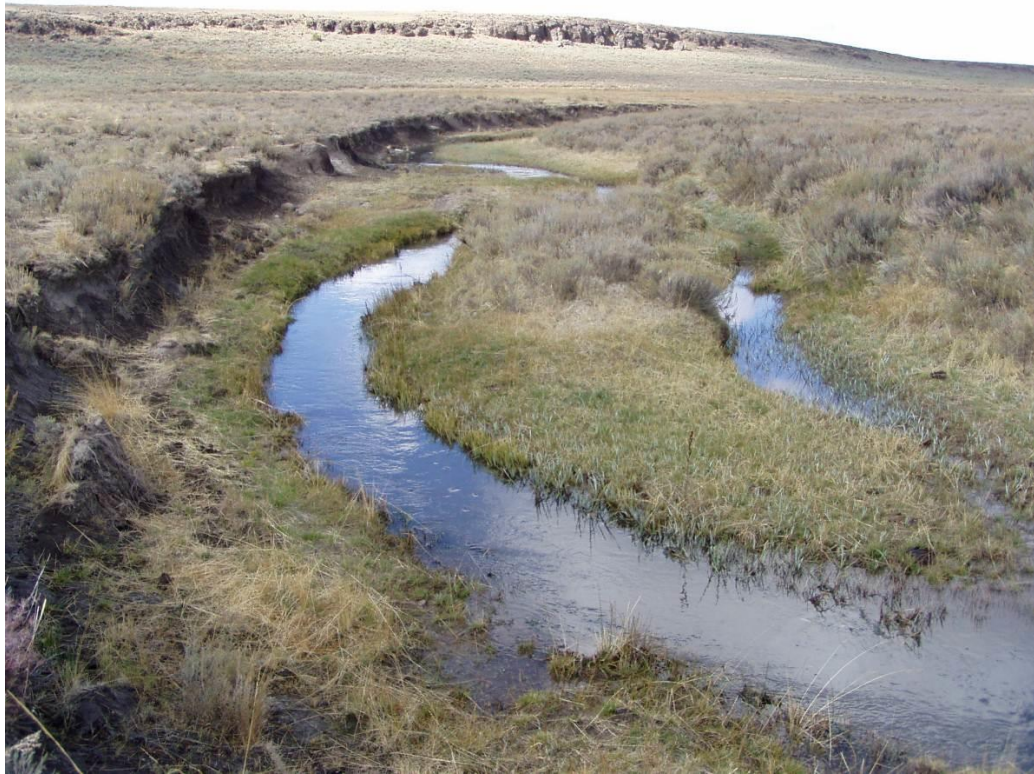
Figure 11. Big Springs Creek, Pasture 8N, October 4, 2005

Riparian areas that are degraded include Big Springs Creek above Twin Bridges (4.2 miles) and a short section of Battle Creek (0.3 miles) upstream of Big Springs Creek and downstream of private land. Big Springs Creek below the Big Springs Ranch is downcut up to 6 feet through a broad flat that is over one mile long (Fig. 11). This flat could be wet meadow if the creek aggraded, and could provide some of the finest sage-grouse brood rearing habitat in Owyhee County. Currently, the banks are vegetated with sedges, but the benches just back from the water support bluegrass. Use levels are generally high, but the sedges at the water's edge regrow after use to almost full height (see Standard 2). The section of Battle Creek below the private land is rated Functioning at Risk and receives high levels of livestock use.

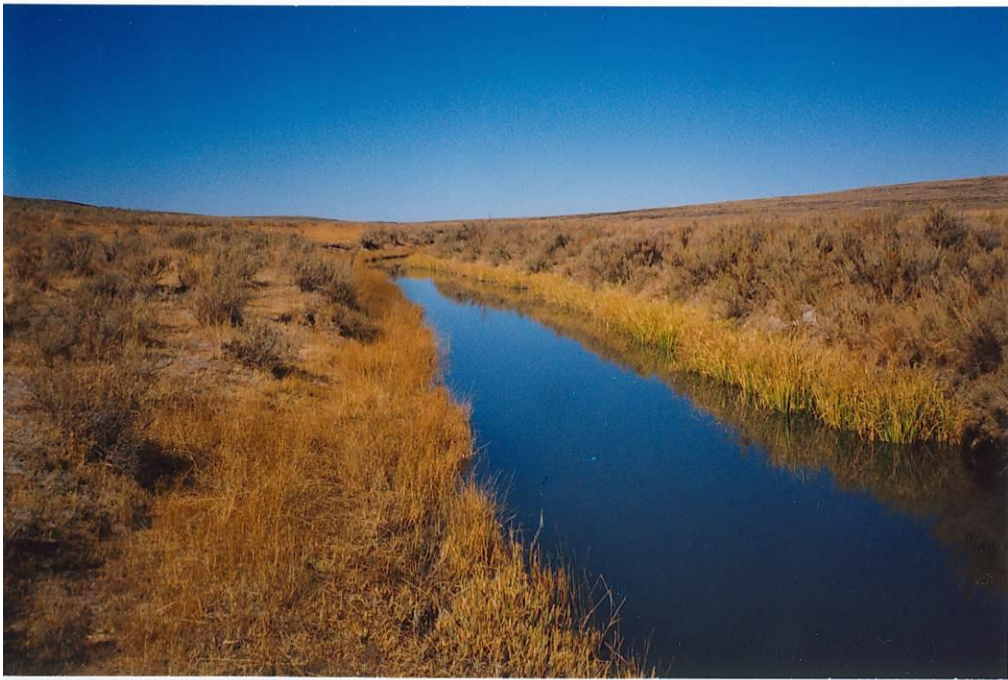
Figure 13. View upstream on Big Springs Creek (Segment 6.3), showing opposite bank vegetated with sedges and near bank dominated by early seral grasses and rushes, 21 October, 1999.

Segment 1.4 has one developing headcut, unstable banks, and lateral erosion. This segment is in FAR condition. Segment 4.8 has four active headcuts, the largest of which is about 3-feet deep. The channel of Segment 6.3 is entrenched about 5-feet-deep from past headcut events, and is at risk of further incision due to the presence of eroding stream banks and floodplains, the lack of willow recruitment, and active headcuts downstream in Segments 4.8 and 1.4.

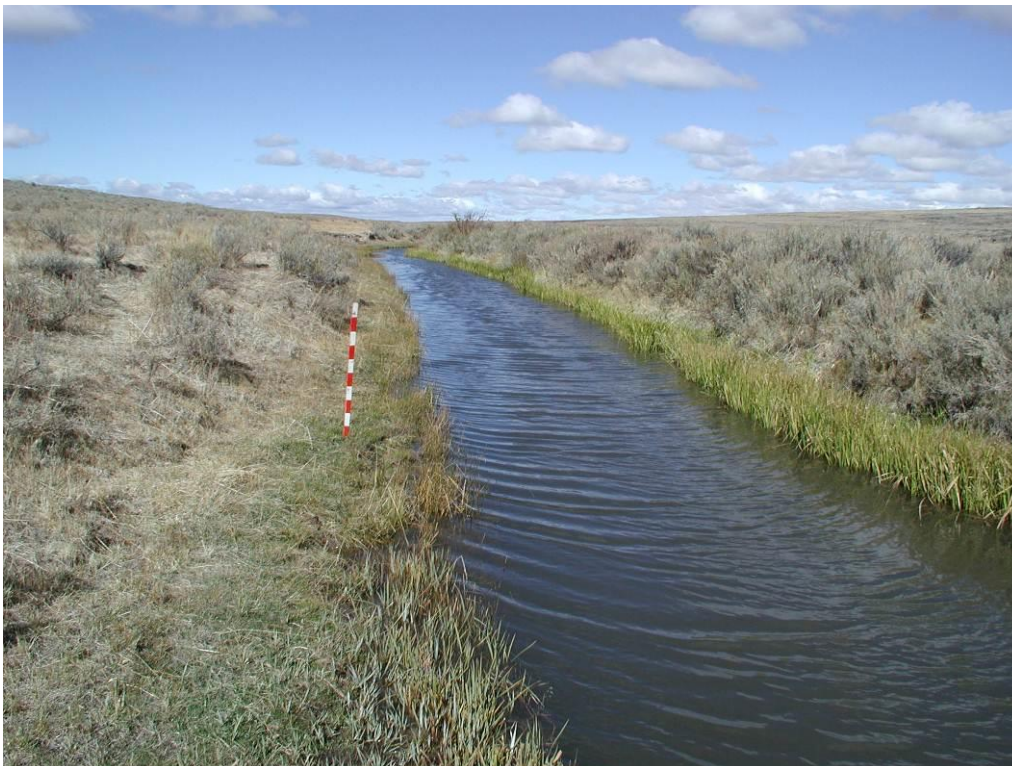
Figure 14. Same view on 4 October 2005. Near bank still dominated by grasses and rushes. Note residual stubble height of vegetation outside of wetted channel (median of about 2.5 inches).

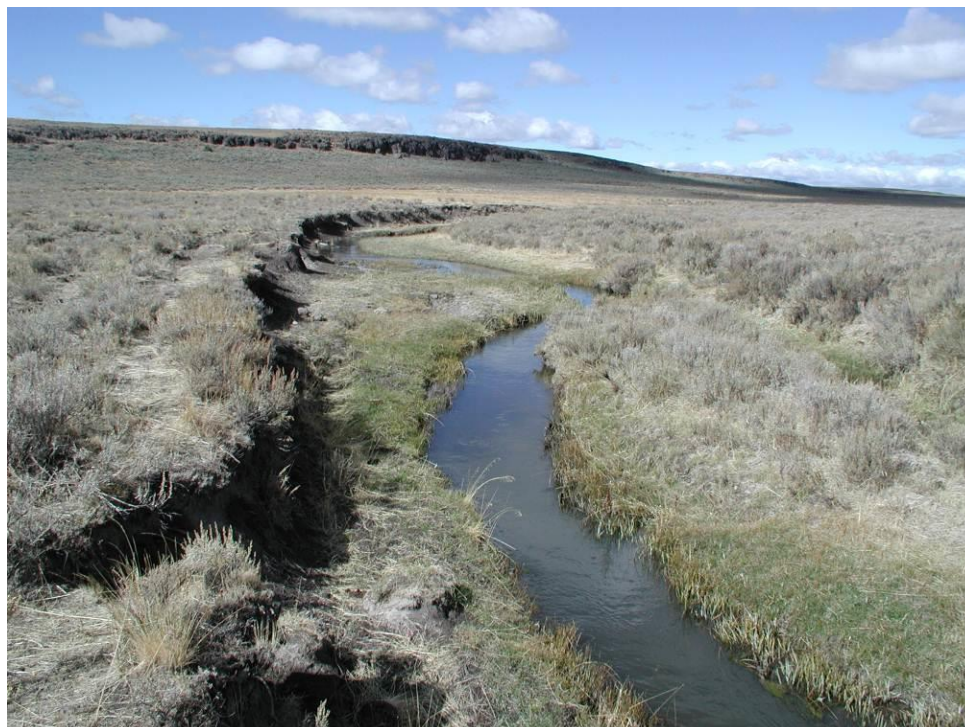
Figure 15. Upstream view of Big Springs Creek (Segment 6.3) in Pasture 8N showing historically incised channel and high use of riparian vegetation on 4 October 2005.

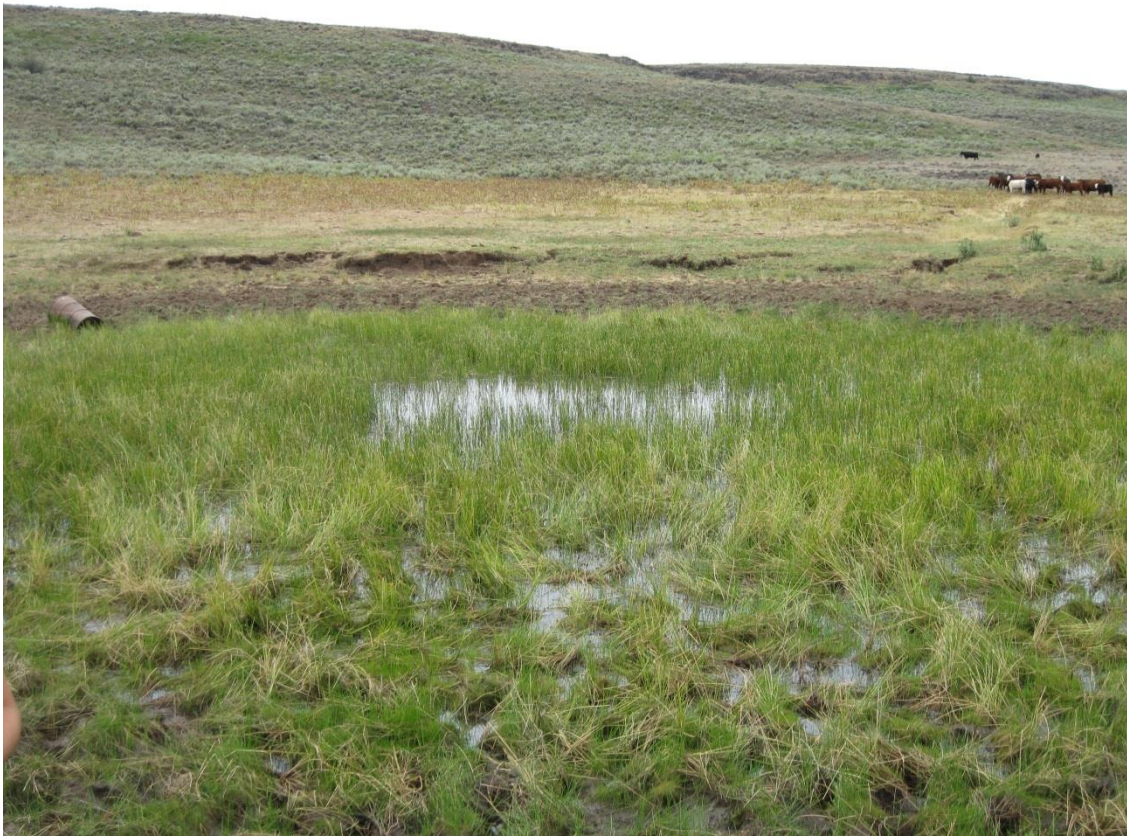
A new population was located nearby at the South Big Springs Reservoir (Figure 16) during 2009. Twenty-five plants were found in this heavily pugged water source. Population vigor was poor given the amount of potential habitat. Most wetland vegetation was restricted to the interior inaccessible portion of the pond, and invasive and noxious weeds such as ventenata grass (*Ventenata dubia*) and Canada thistle (*Cirsium arvense*), respectively, were present on the pond berm.

Figure 16. Population #2 of Bach's downingia at South Big Springs Reservoir.

Species	Pasture	Habitat	Status	# of Populations	Summary of Conditions
Bach's downingia	8N	Drying mud of vernal pools, muddy lake margins, wet meadows, roadsides, irrigation ditches, and stream banks.	BLM Sensitive, Type 4	2	<p>#1. 1999-approximately 30 to 50 plants along intermittent drainage, numerous in fruit, threats include habitat degradation and mechanical damage. 2005-heavy mechanical damage around ponded area, only one plant found; not accessed in 2009.</p> <p>#2. Discovered in 2009 at South Big Springs Reservoir. 25 Plants in flower and fruit. Heavy use and deep pugging of soils. Habitat in very poor condition for species persistence.</p>
